HOME INSPECTION REPORT

1111 Sun and Fun Lane Palm Springs CA 92262.

Inspected on Sometime in 2012

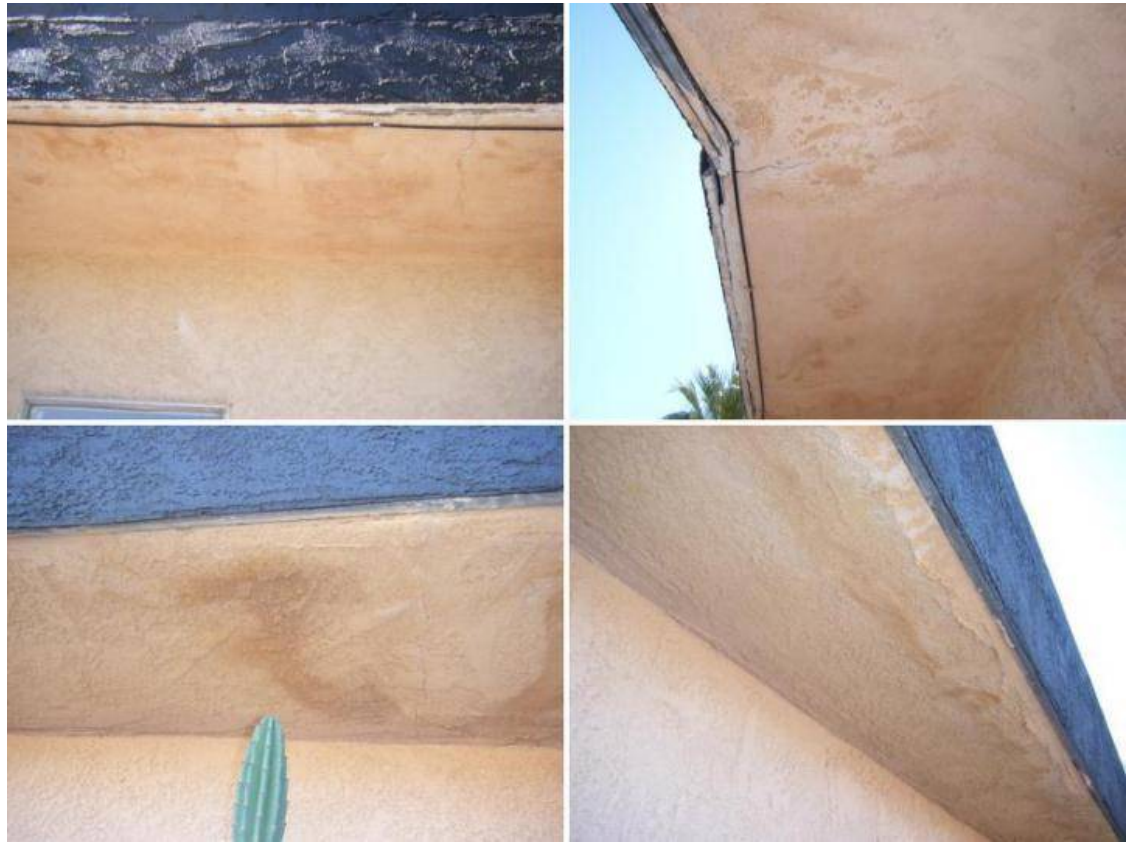
Settling cracks are noted

There are several cracks, a section of missing stucco and several water stains noted along the overhang on the North and East sides of the property. Further evaluation by a licensed contractor is recommended.

2. There are several cracks, a section of missing stucco and several water stains noted along the overhang on the North and East sides of the property. Further evaluation by a licensed contractor is recommended.

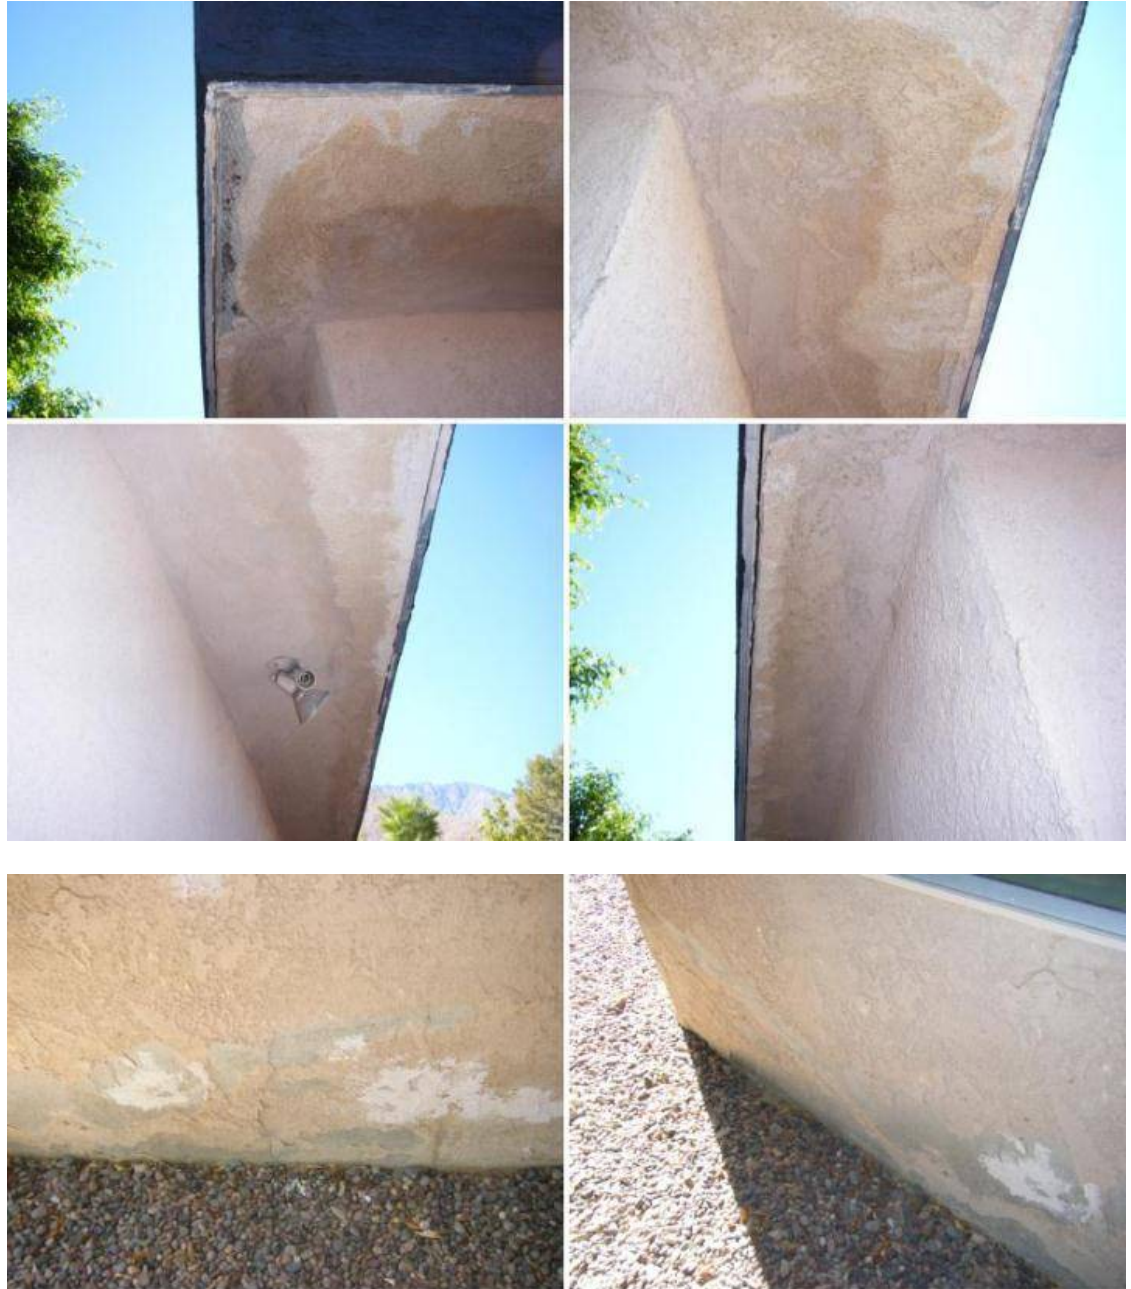
There is deteriorated color coat noted at a few section of the stucco walls.

1. There is deteriorated color coat noted at a few section of the stucco walls.

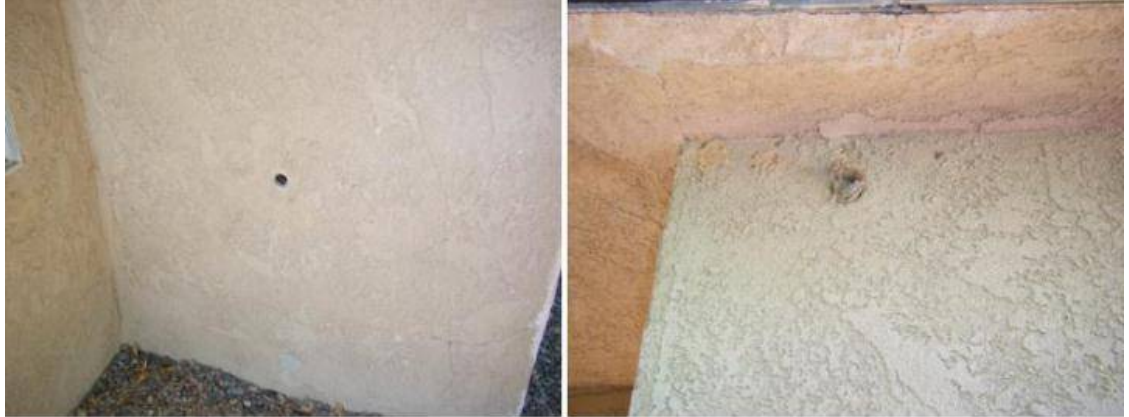
There are two holes cut into the stucco of the East mechanical closet and damaged stucco at the bottom-left of the mechanical room doors.

2. There are two holes cut into the stucco of the East mechanical closet and damaged stucco at the bottom-left of the mechanical room doors.

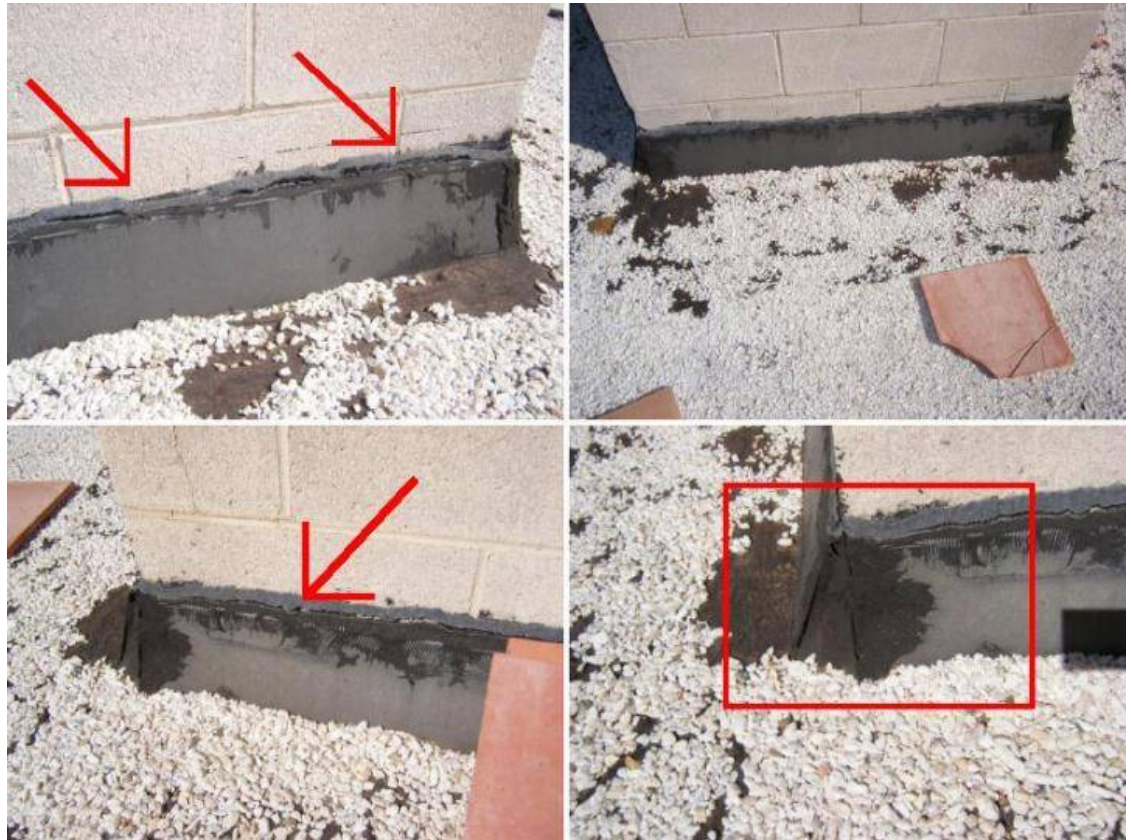
There is cracked caulking at the flashing and cracked corners noted at the living room's chimney. Further evaluation by a licensed roofing contractor is recommended. Spark arrester noted.

3. There is cracked caulking at the flashing and cracked corners noted at the living room's chimney. Further evaluation by a licensed roofing contractor is recommended.

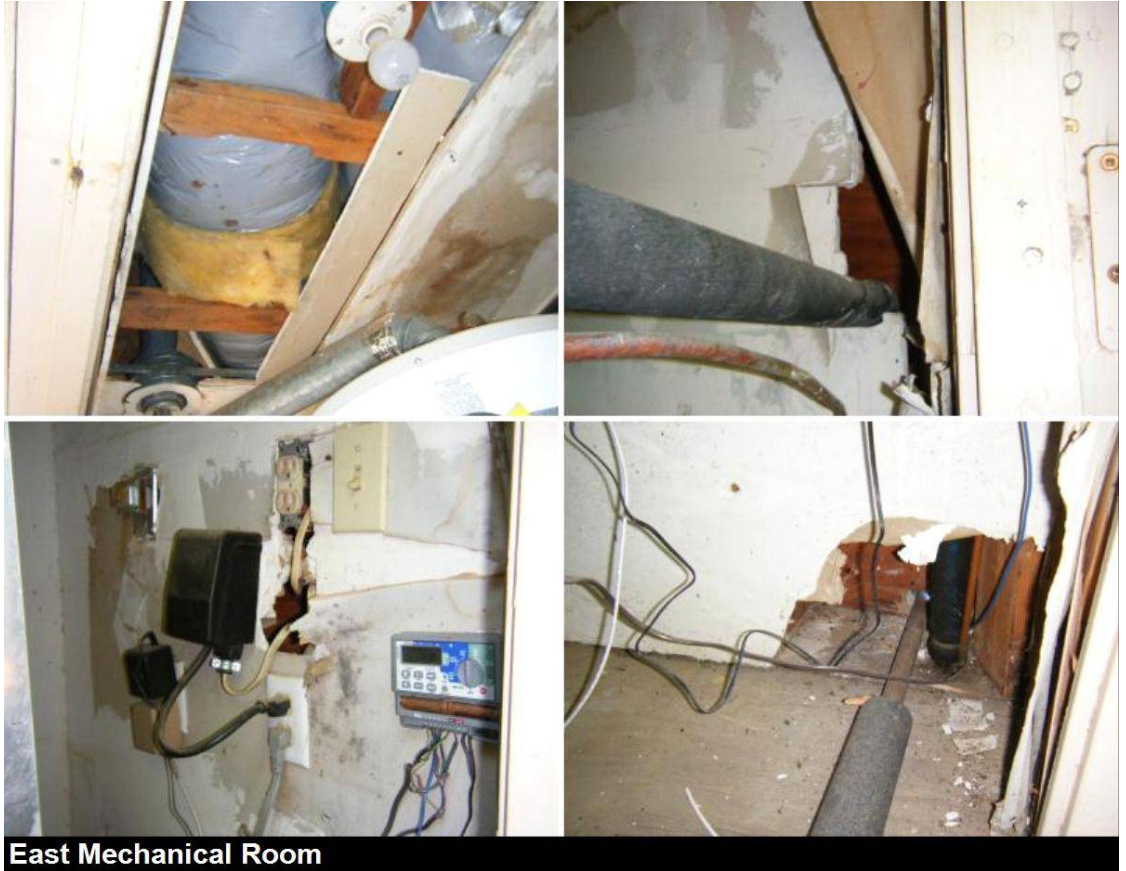
East Mechanical Room

There is missing drywall and several holes noted in both mechanical closets. Repairs are recommended.

4. There is missing drywall and several holes noted in both mechanical closets. Repairs are recommended.

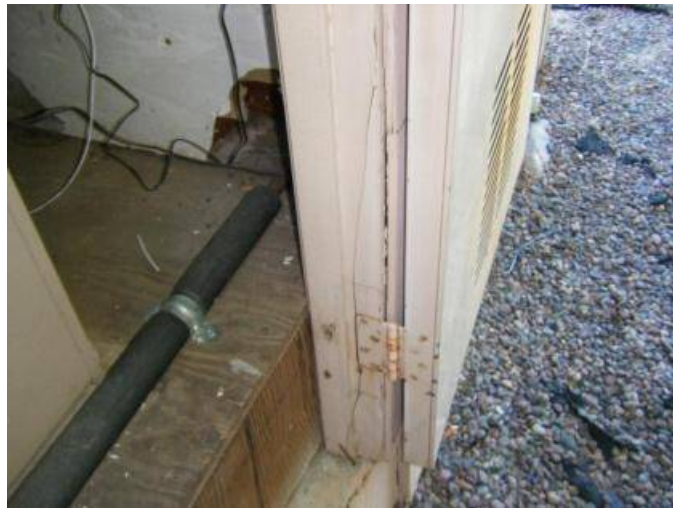
The jamb of the East mechanical closet is cracked.

5. The jamb of the East mechanical closet is cracked.

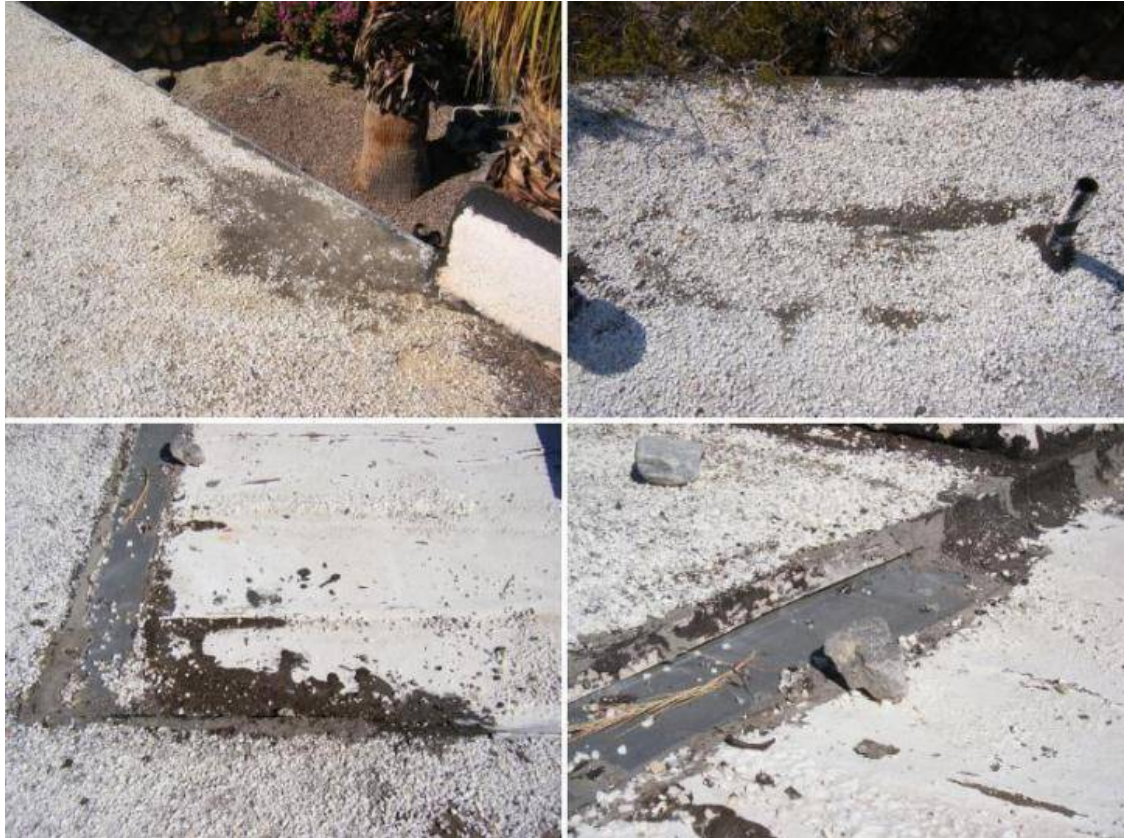
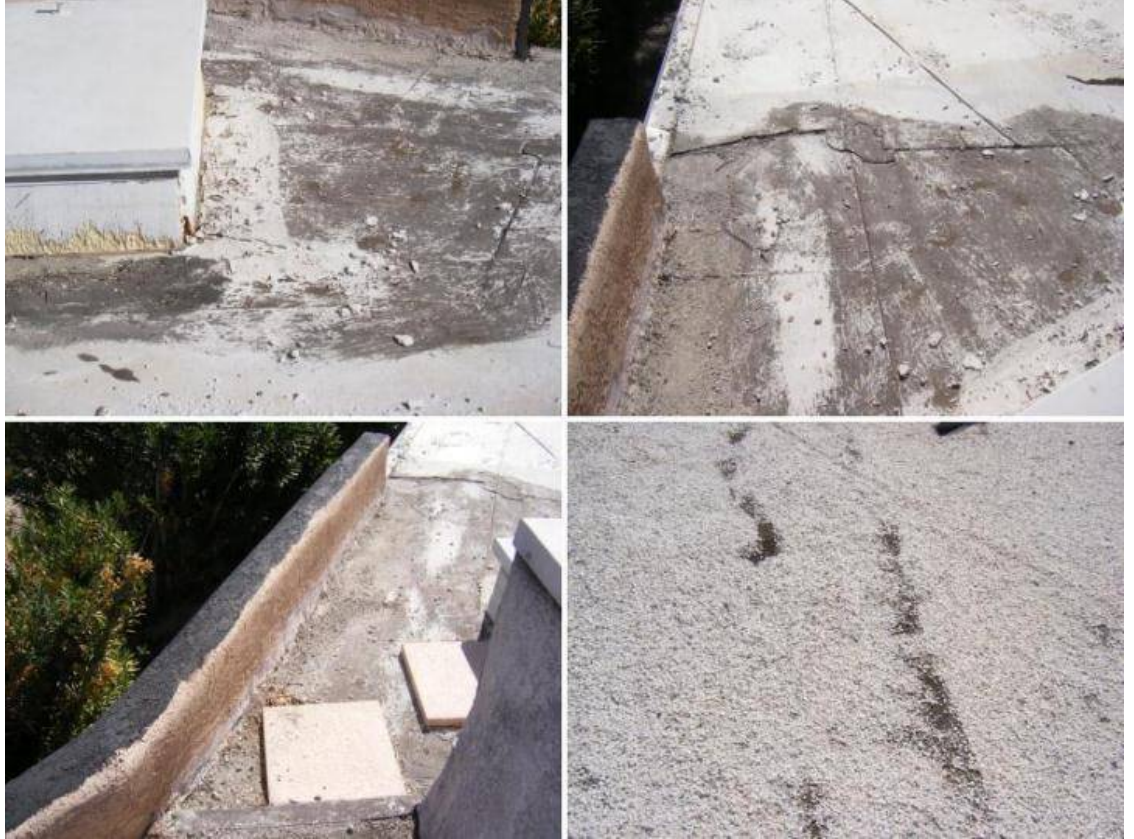
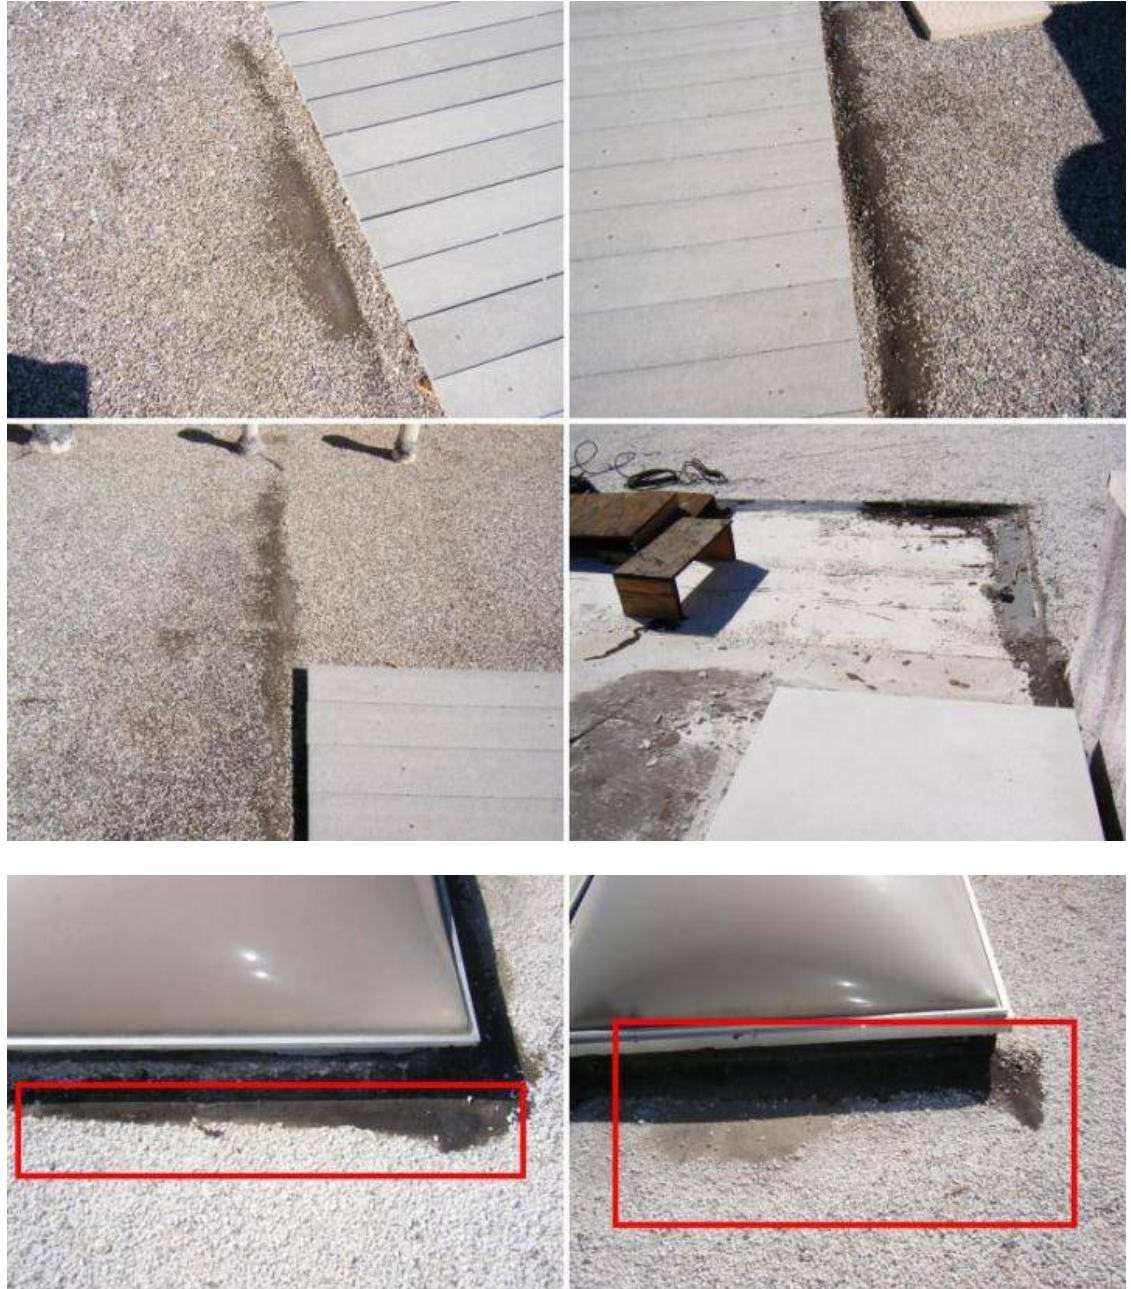
There are several areas of missing rocks that have exposed emulsion. The area over the fitness center has seen many patches. Due to the many missing rock areas, the questionable area over the fitness center and the many water stains to the overhang, we recommend further evaluation by a licensed roofing contractor.

4. There are several areas of missing rocks that have exposed emulsion. The area over the fitness center has seen many patches. Due to the many missing rock areas, the questionable area over the fitness center and the many water stains to the overhang, we recommend further evaluation by a licensed roofing contractor.

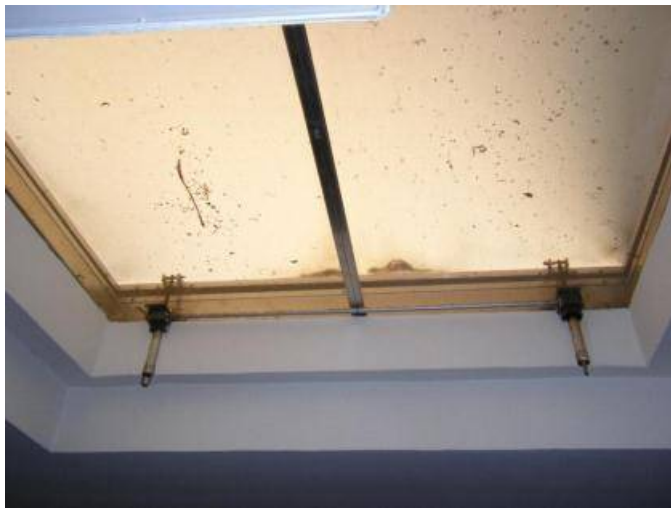
The crank-to-open skylight in the office could not be tested as cranks were not located.

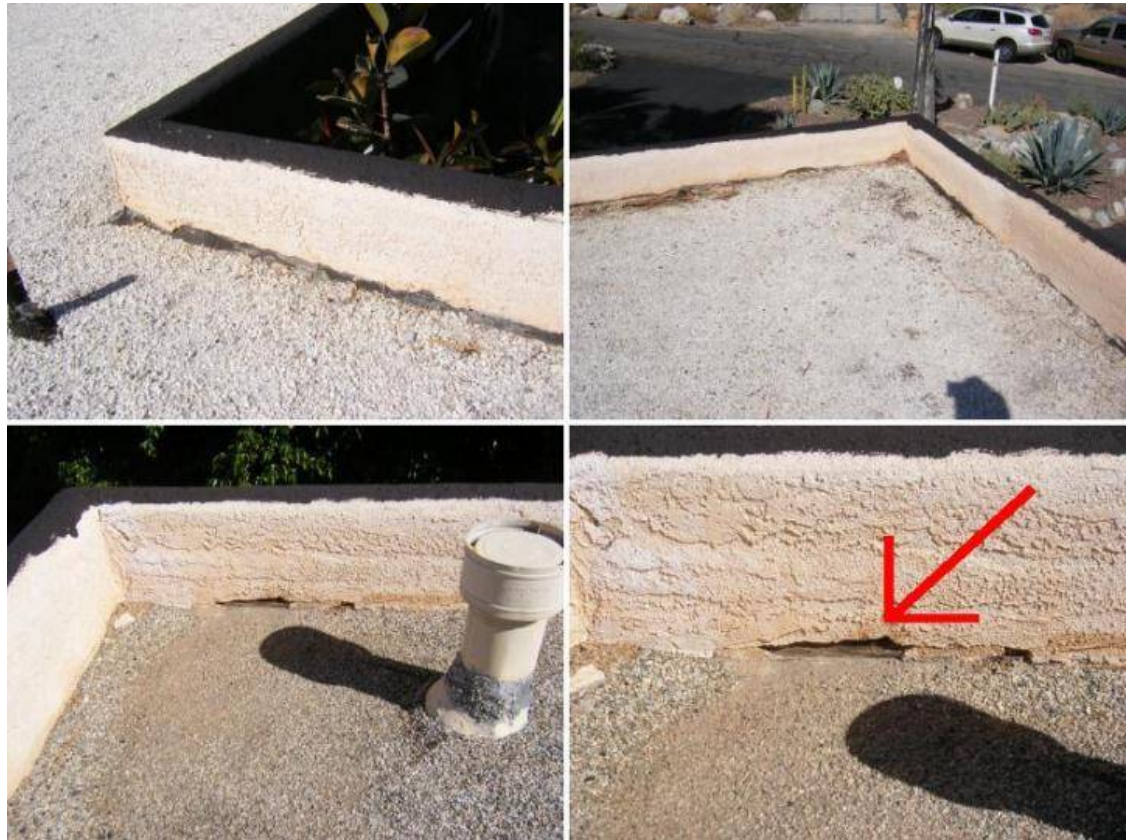
Metal flashing is not present along the stucco build up areas. Sections of the build up have deteriorated with exposed wood noted. Further evaluation by a licensed roofing contractor is recommended.

5. Metal flashing is not present along the stucco build up areas. Sections of the build up have deteriorated with exposed wood noted. Further evaluation by a licensed roofing contractor is recommended.

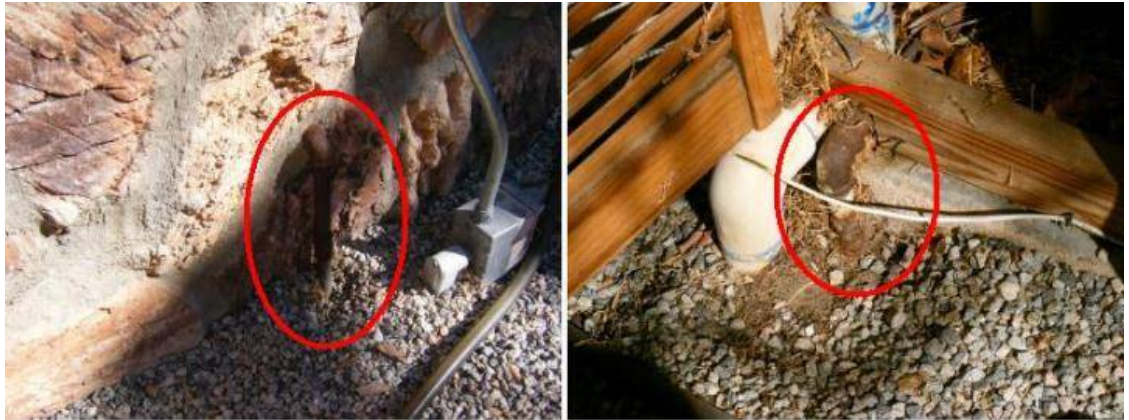
The gas line to the West furnace and to the barbecues are in direct contact with soil, is not rust protected and is rusting. Gas pipes in contact with soil should have factory applied rust protective coating applied. Further evaluation by a licensed plumbing contractor is recommended.

6. The gas line to the West furnace and to the barbecues are in direct contact with soil, is not rust protected and is rusting. Gas pipes in contact with soil should have factory applied rust protective coating applied. Further evaluation by a licensed plumbing contractor is recommended.

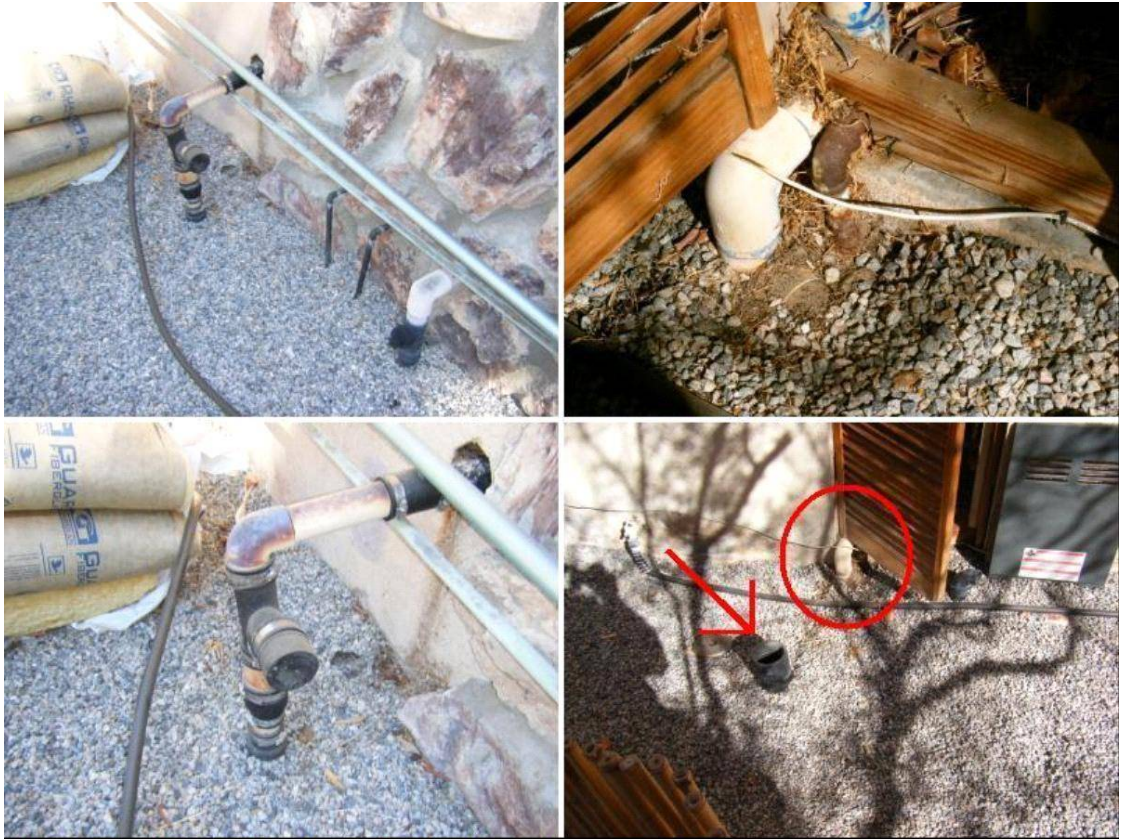
Many plumbing defects noted to drain lines

There are exposed PVC pipes on the West side yard that are being used as drain pipes. PVC should not be exposed as it will deteriorate from the sun.

An uncovered ABS pipe is noted on the West side yard, near the furnace closet.

Further evaluation and repairs by a licensed plumbing contractor is recommended.

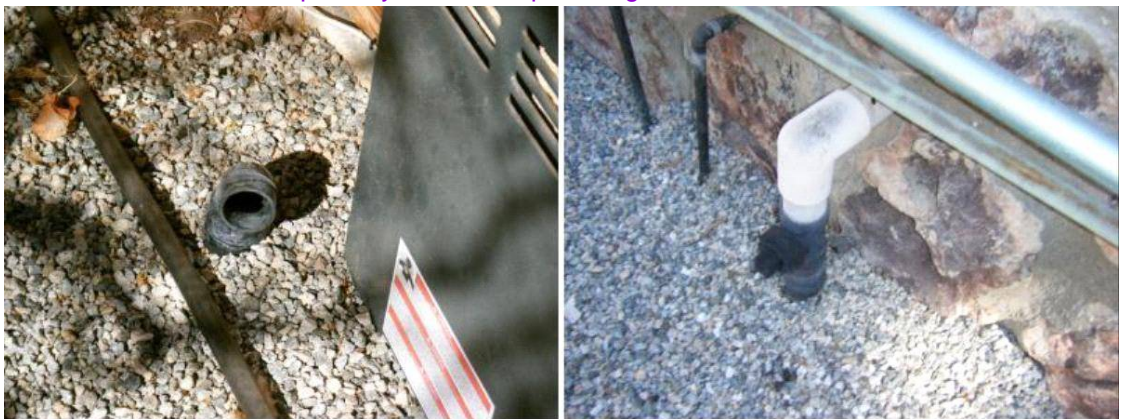
ABS & PVC glued together and an open pipe

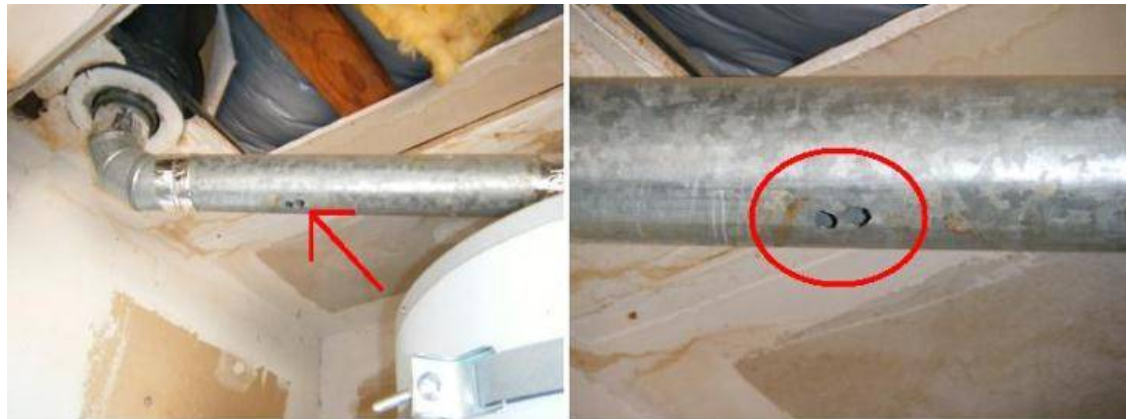
There are two holes noted in the vent.

8. There are two holes noted in the vent.

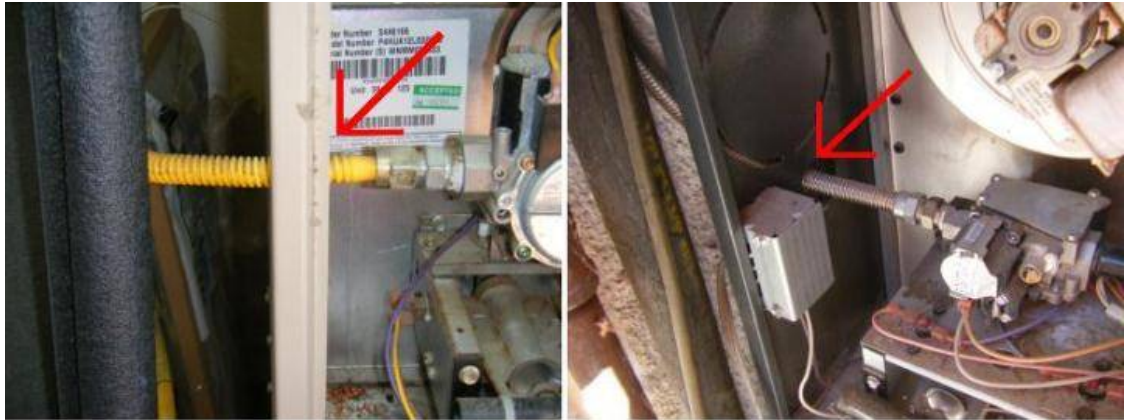
Flexible gas connectors should not pass through a heaters cabinet or be located inside the heaters enclosure. Flexible gas connectors should connect to a rigid gas line just outside the heater and the rigid line then pass through the cabinet and connect to the heater. This is a newer restriction that may not have been in effect at time of installation, however we recommend compliance as a safety upgrade.

1. Flexible gas connectors should not pass through a heaters cabinet or be located inside the heaters enclosure. Flexible gas connectors should connect to a rigid gas line just outside the heater and the rigid line then pass through the cabinet and connect to the heater. This is a newer restriction that may not have been in effect at time of installation, however we recommend compliance as a safety upgrade.

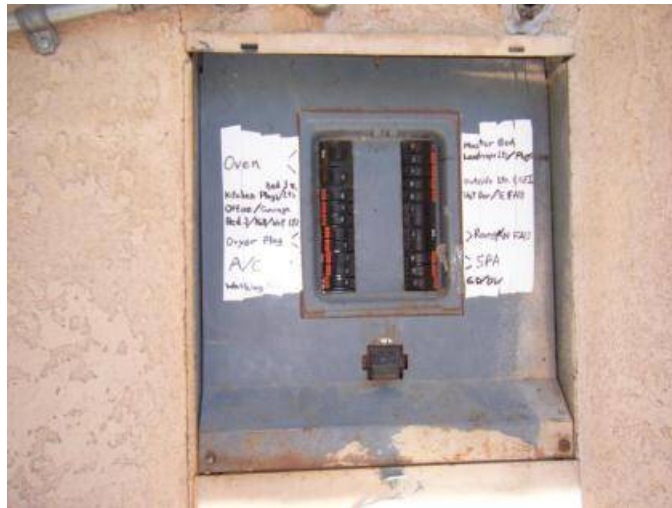
This is a Federal Pacific Electric (FPE) Stab-Loc electric service panel. These panels are no longer manufactured. There is ongoing controversy regarding the reliability of the circuit breakers to trip (switch off) under an overload condition and the poor design of the circuit breaker attachment mechanism can result in an improperly installed circuit breaker that can overheat rendering it ineffective. A circuit breaker that may not trip in an overload condition does not afford the protection that is intended or required. A defective circuit breaker can function for years without any noticeable problems. Testing by private engineers and the Consumer Product Safety Commission has resulted in failures of some breakers to trip when required. Although there has never been a formal recall of FPE panels and breakers it is my opinion and the opinion of many building inspectors in the country that FPE panels are a latent defect that may not provide the protection for which they were designed and should, therefore, be replaced with modern equipment. You can obtain more information about FPE panels by accessing www.inspectapedia/fpe/fpepanel.htm. If you elect to keep this panel in service I recommend that it be fully evaluated by an electrical contractor familiar with the problems associated with FPE panels prior to making your final purchase decision and periodically throughout the service of the panel. In addition, it is important that you react to any abnormality with your electrical service, such as dimming or flickering lights, with additional inspections.

1. This is a Federal Pacific Electric (FPE) Stab-Loc electric service panel. These panels are no longer manufactured. There is ongoing controversy regarding the reliability of the circuit breakers to trip (switch off) under an overload condition and the poor design of the circuit breaker attachment mechanism can result in an improperly installed circuit breaker that can overheat rendering it ineffective. A circuit breaker that may not trip in an overload condition does not afford the protection that is intended or required. A defective circuit breaker can function for years without any noticeable problems. Testing by private engineers and the Consumer Product Safety Commission has resulted in failures of some breakers to trip when required. Although there has never been a formal recall of FPE panels and breakers it is my opinion and the opinion of many building inspectors in the country that FPE panels are a latent defect that may not provide the protection for which they were designed and should, therefore, be replaced with modern equipment. You can obtain more information about FPE panels by accessing www.inspectapedia/fpe/fpepanel.htm. If you elect to keep this panel in service I recommend that it be fully evaluated by an electrical contractor familiar with the problems associated with FPE panels prior to making your final purchase decision and periodically throughout the service of the panel. In addition, it is important that you react to any abnormality with your electrical service, such as dimming or flickering lights, with additional inspections.

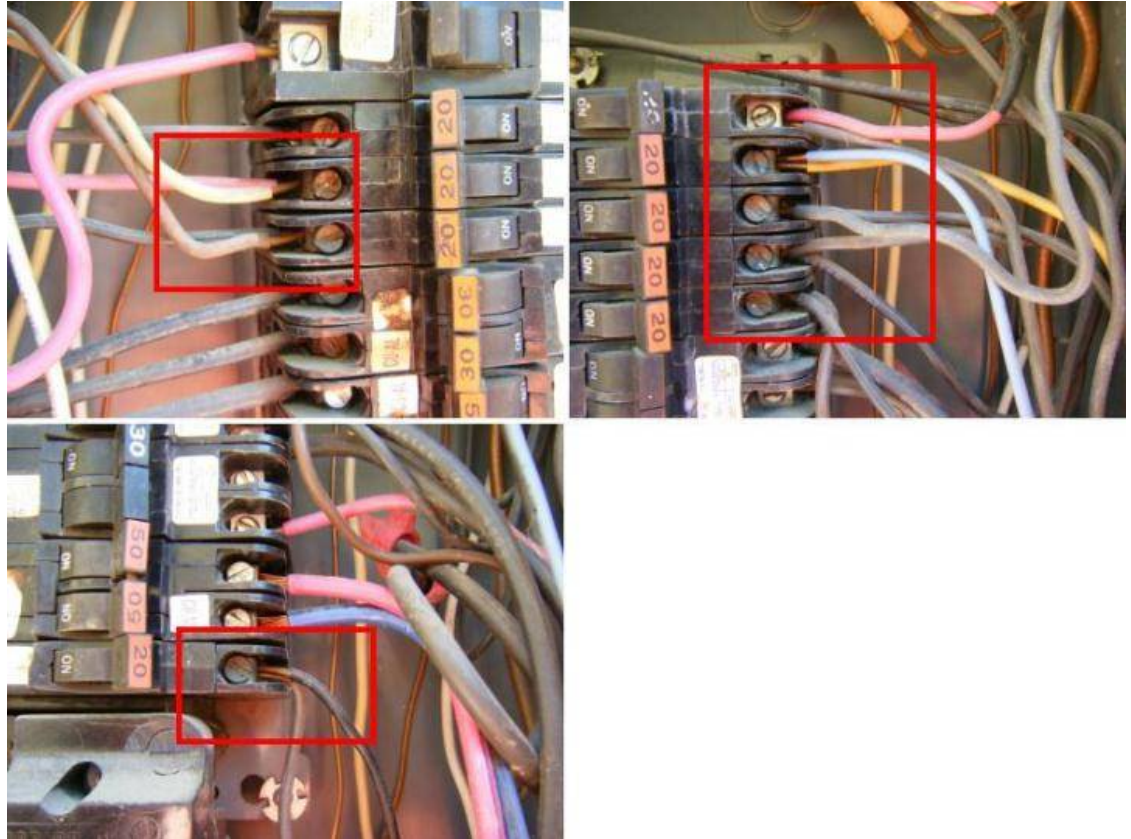
There are nine double tapped breakers. These are two wires connected to a breaker that should have only one wire connected to it. Double tapping can overload circuits, breakers, wires, equipment and could be considered a fire hazard. Further evaluation and repair by a licensed electrician is recommended.

9. There are nine double tapped breakers. These are two wires connected to a breaker that should have only one wire connected to it. Double tapping can overload circuits, breakers, wires, equipment and could be considered a fire hazard. Further evaluation and repair by a licensed electrician is recommended.

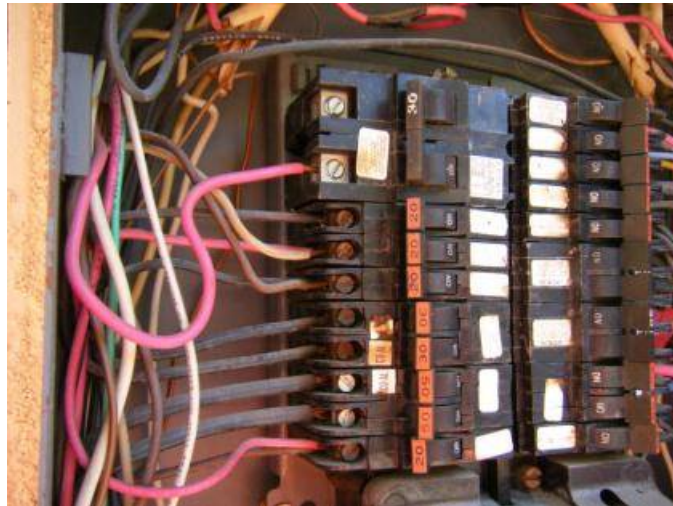
Due to the outdated FPE panels and the excessive amount of double tapped breakers, we recommend having a new (larger) electrical panel installed.

10. Due to the outdated FPE panels and the excessive amount of double tapped breakers, we recommend having a new (larger) electrical panel installed.

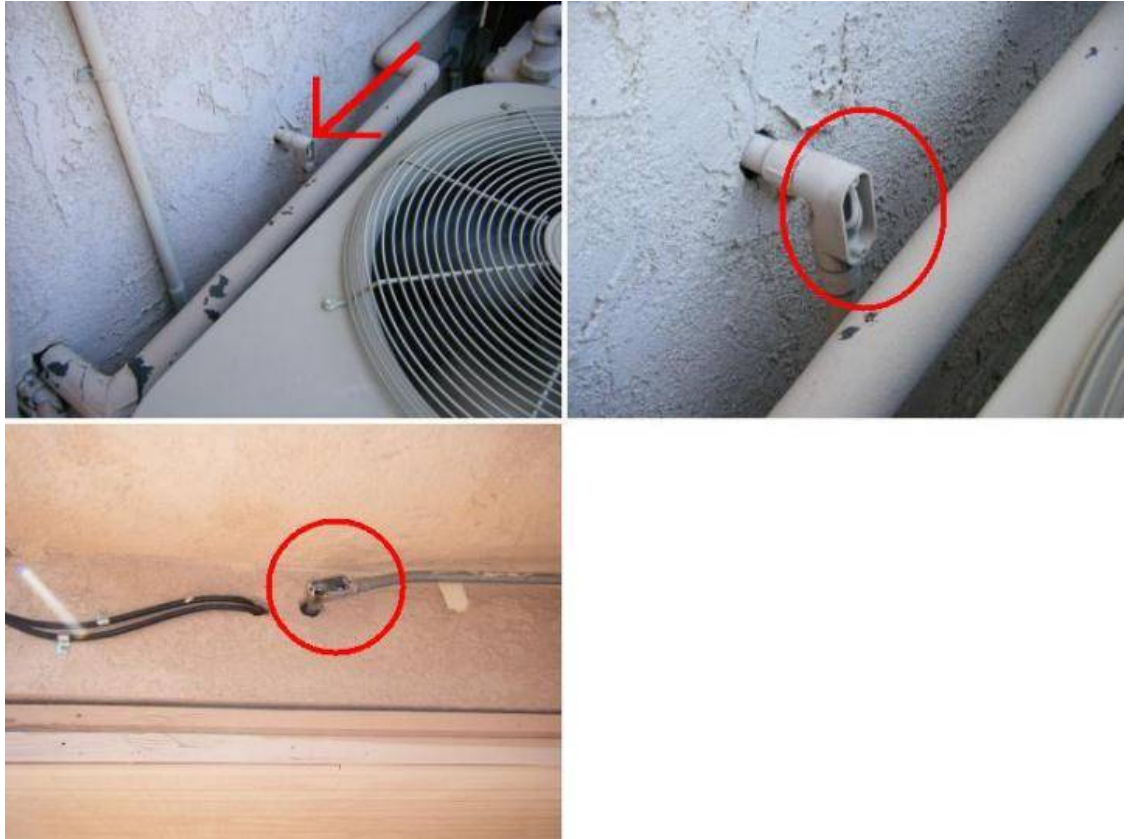
There are uncovered conduit 90 degree elbows noted behind the East air conditioner and on the East side of the rear patio. Covers should be installed.

6. There are uncovered conduit 90 degree elbows noted behind the East air conditioner and on the East side of the rear patio. Covers should be installed.

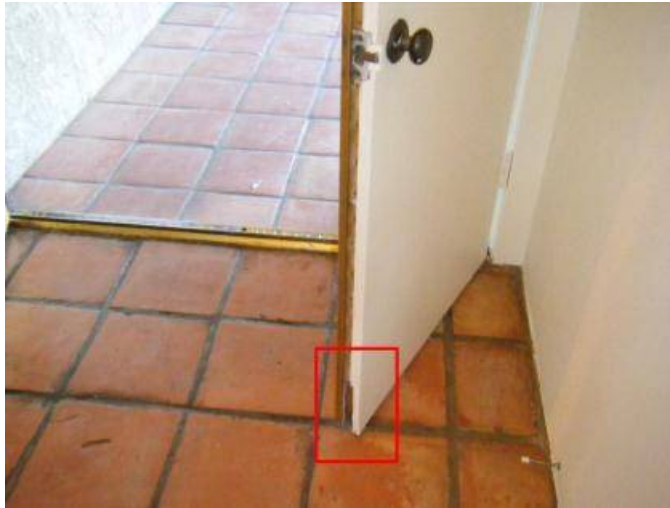
The bottom latch/lock to the slave door is missing.

7. The bottom latch/lock to the slave door is missing.

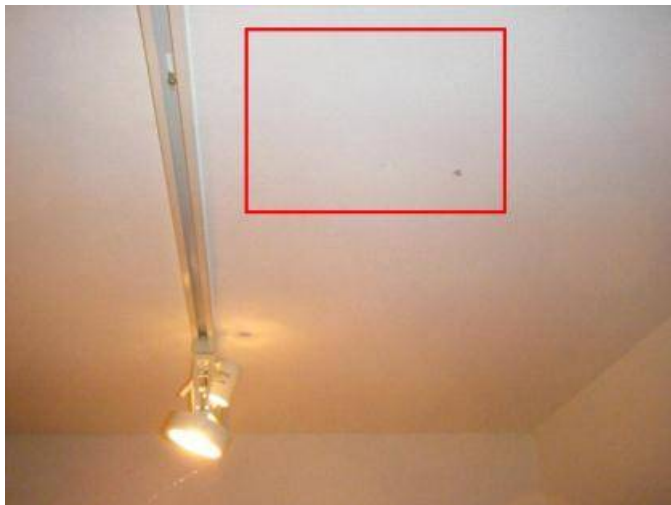
Drywall, Settling cracks are noted.

Mud tubes are noted in the ceiling of the master bedroom closet, refer to Wood Destroying Organism inspection report.

12. Mud tubes are noted in the ceiling of the master bedroom closet, refer to Wood Destroying Organism inspection report.

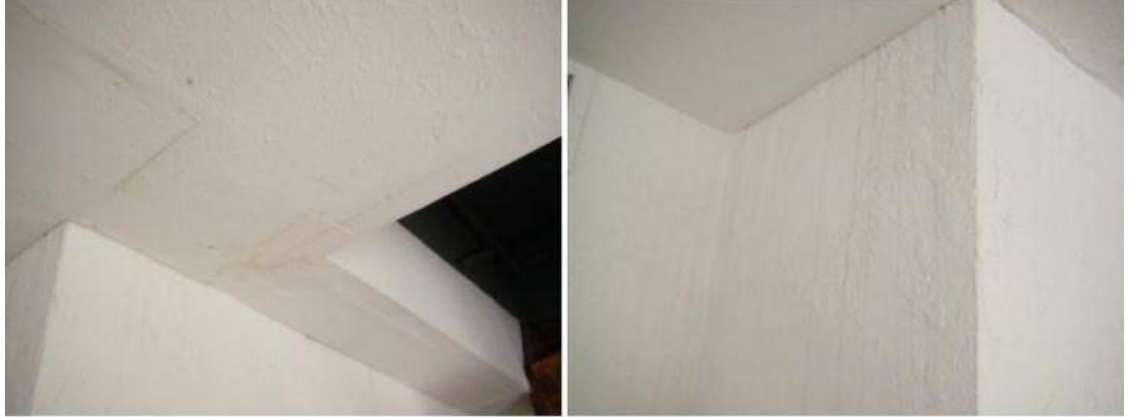
Water stains are noted in the fitness room and coming down the back side of the master bedroom fireplace.

8. Water stains are noted in the fitness room and coming down the back side of the master bedroom fireplace.

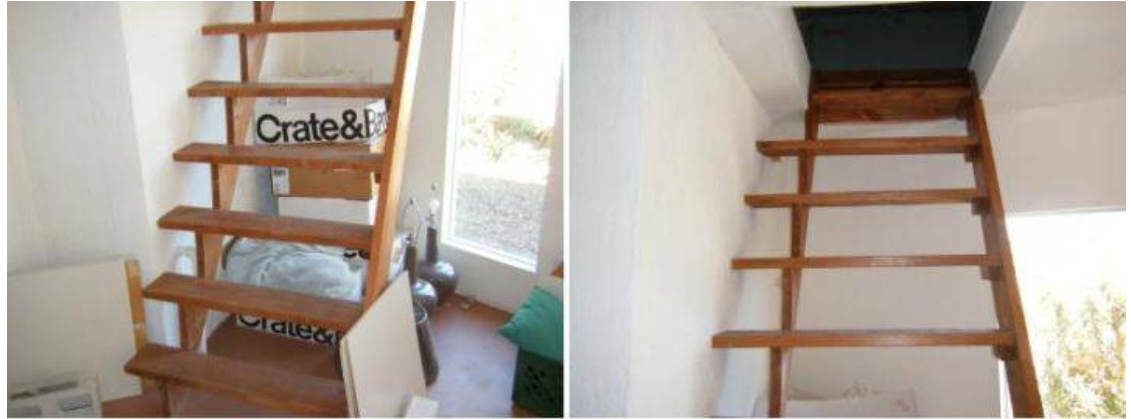
The steps from the fitness room up to the roof are improper sized, improper angled and without a handrail. Stair treads should be a minimum depth of 10 inches and a maximum riser height of 7 3/4 inches.

2. The steps from the fitness room up to the roof are improper sized, improper angled and without a handrail. Stair treads should be a minimum depth of 10 inches and a maximum riser height of 7 3/4 inches.

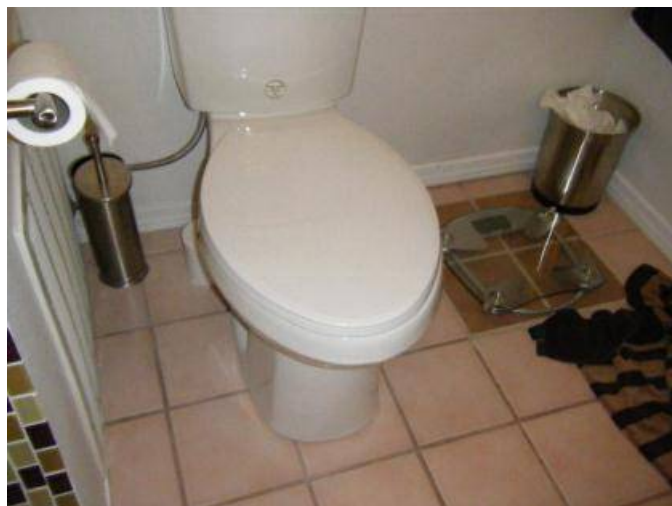
Toilet is loose at the floor, tightening is recommended.

9. Toilet is loose at the floor, tightening is recommended.

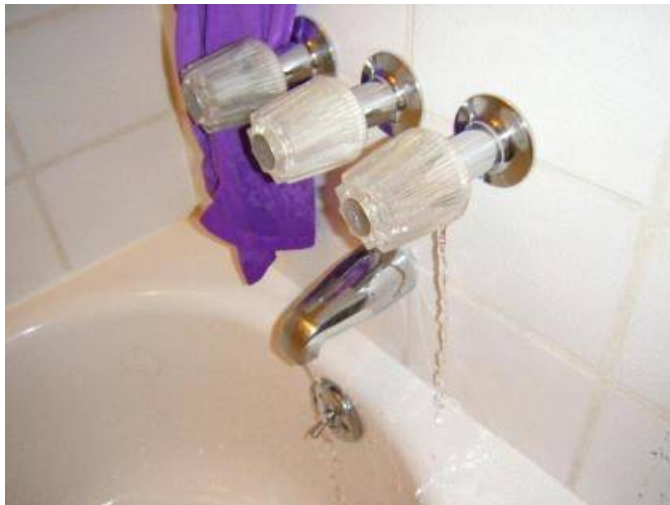
Water leaks at the cold water shower's handle.

10. Water leaks at the cold water shower's handle.

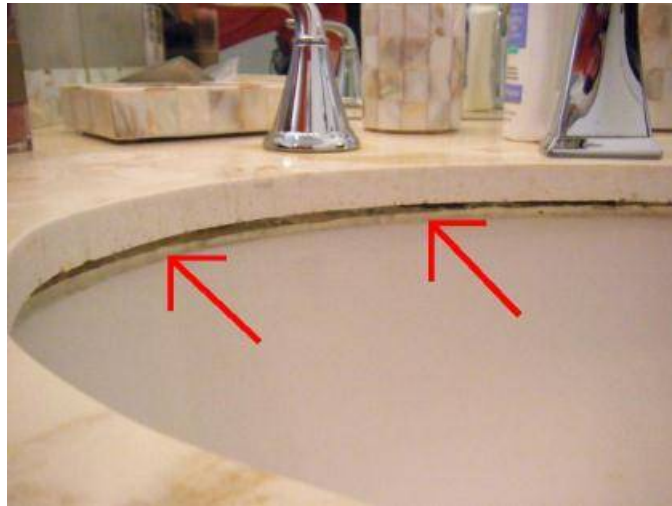
The right sink should be caulked to the counter.

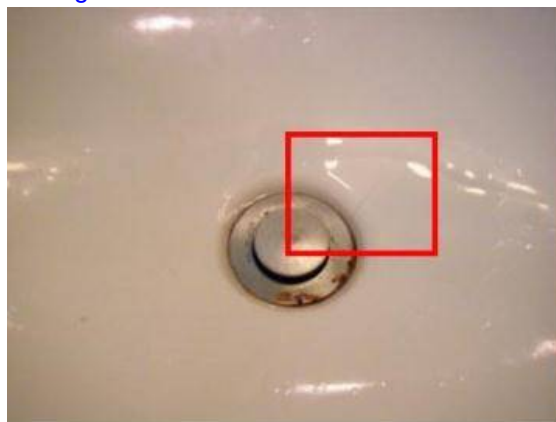
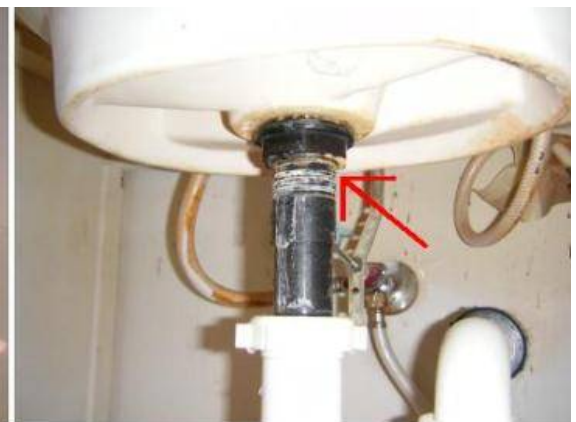
The left sink is cracked and leaks water at the sink's connection to the drain.

13. The left sink is cracked and leaks water at the sinks connection to the drain.

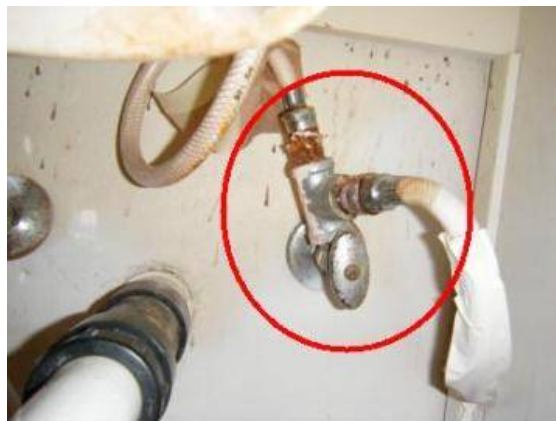
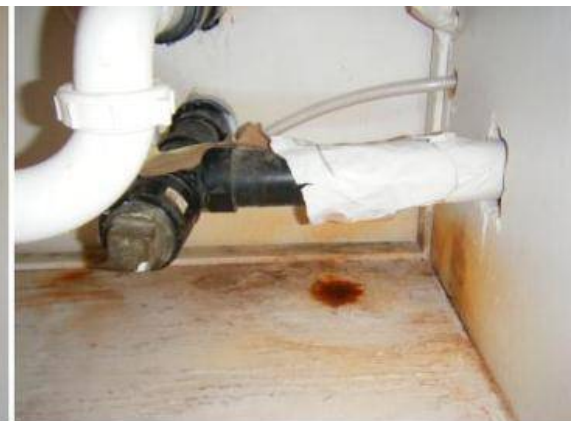
Water is leaking at the left sink's cold water angle stop valve.

14. Water is leaking at the left sink's cold water angle stop valve.

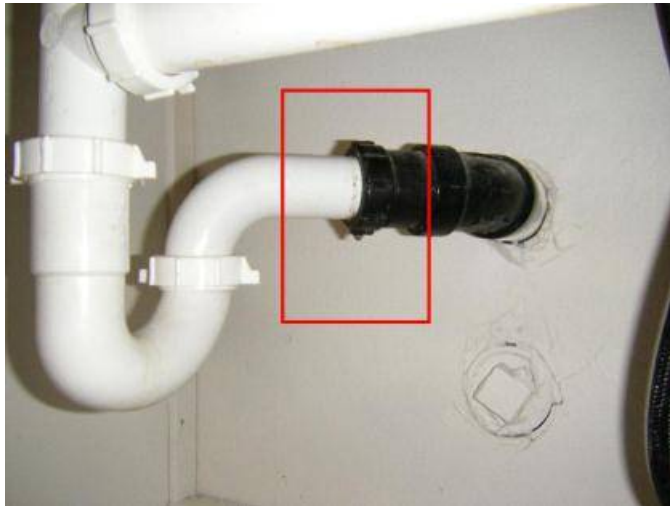
A water leak is noted at the white drain line's connection to the ABS pipe.

15. A water leak is noted at the white drain line's connection to the ABS pipe.

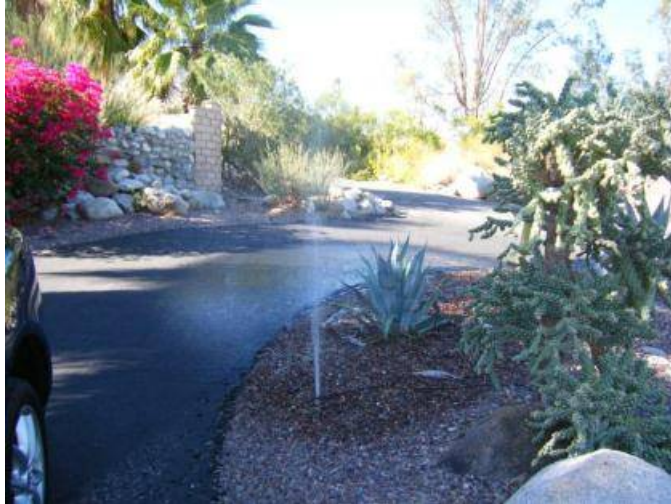
There is a broken dripper noted at the driveway.

16. There is a broken dripper noted at the driveway.
