HOME INSPECTION REPORT

1111 Sun and Fun Lane Palm Springs CA 92262.

Inspected on Sometime in 2012

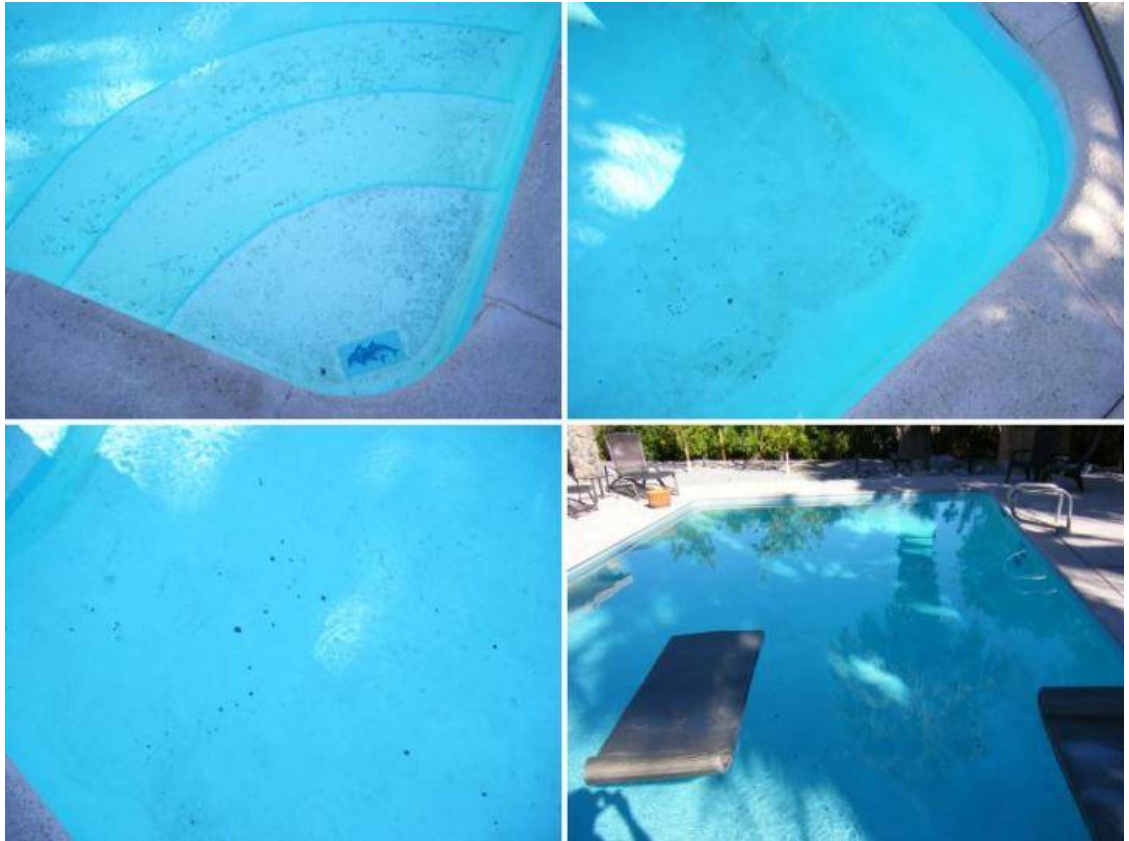
Surface is in poor condition, with several chipped areas of plaster noted.

14. Surface is in poor condition, with several chipped areas of plaster noted.

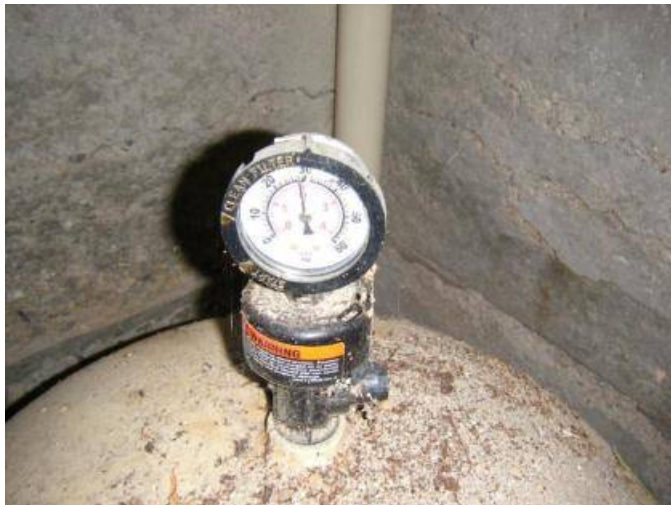
28 PSI. Pressure is a bit high and filter element may be in need of cleaning or replacement.

15. 28 PSI. Pressure is a bit high and filter element may be in need of cleaning or replacement.

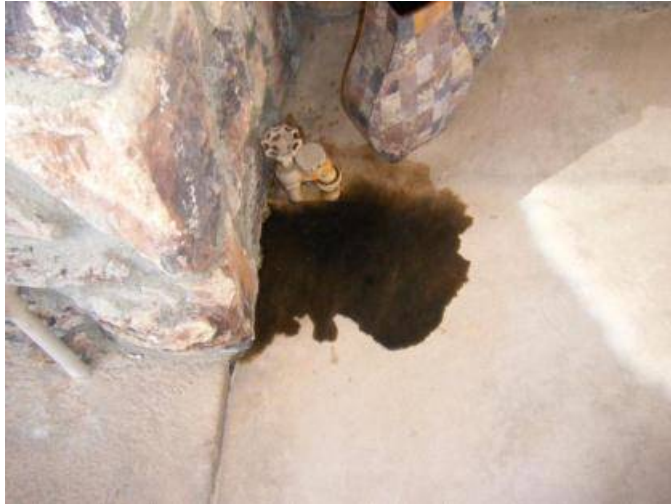
Unit is not operable, water spills out the top of the valve when it is turned on. The pool has been filled with a hose. Repairs are recommended.

16. Unit is not operable, water spills out the top of the valve when it is turned on. The pool has been filled with a hose. Repairs are recommended.

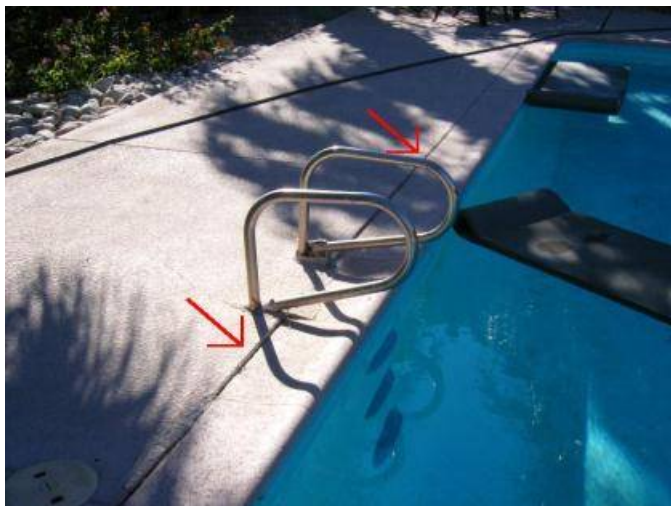
The bond beam near the railing has sunken lower than the rest of the decking.

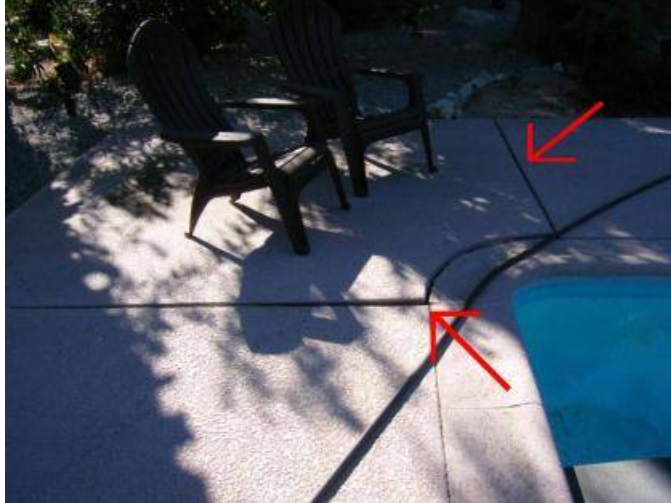
There is a raised section of deck noted at the Southwest section of the pool.

18. There is a raised section of deck noted at the Southwest section of the pool.

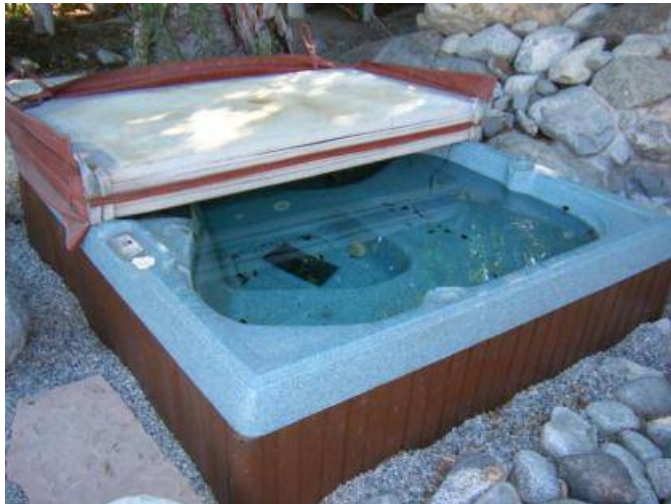
Hot tub did not respond to test.

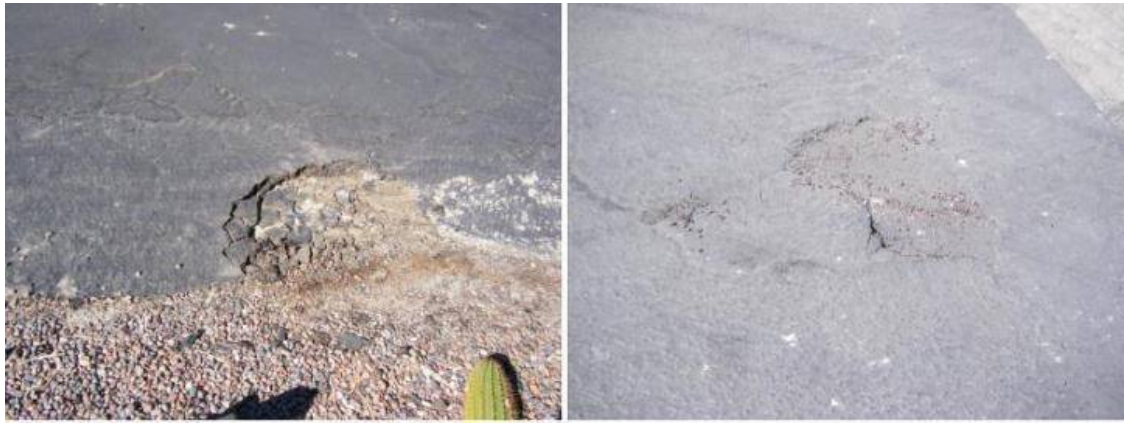
There are two "pot holes" noted that we recommend having filled.

18. There are two "pot holes" noted that we recommend having filled.

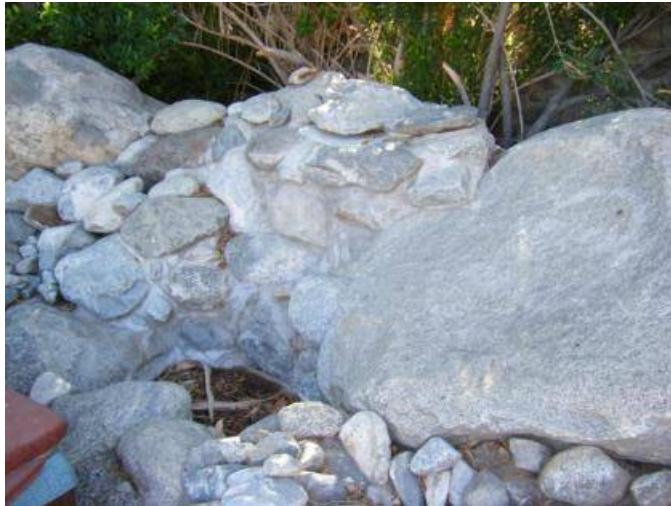
The waterfall fountain is not operable.

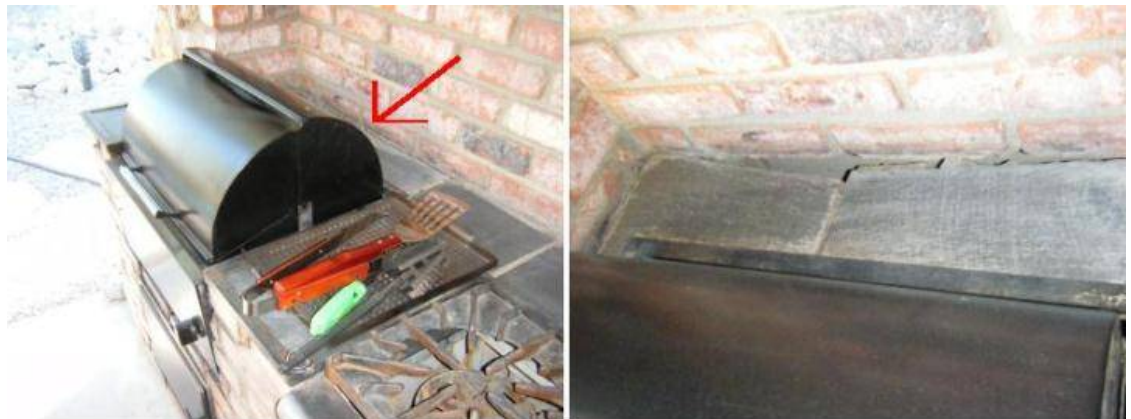
There are two broken tiles noted behind the left barbecue.
Units were lit with a match.
